UNITED STATES ENVIRONMENTAL PROTECTION AGENCY

Re: Notice of Violation Compliance Evaluation Inspection ILD 074 367 251

Attachment 1 Circuit Engineering, LLC-RCRA ID: ILD 074 367 251 July 17, 2015

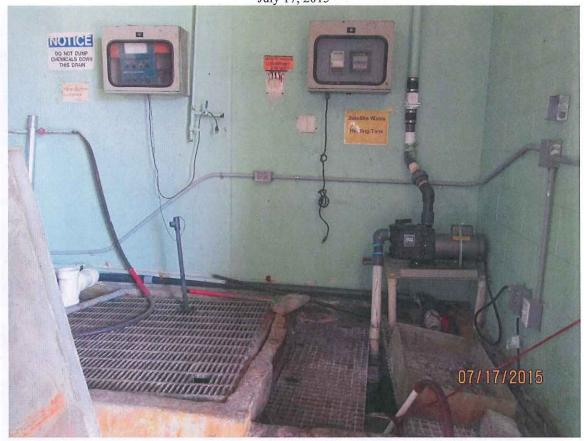
Photo 3. Photographer: G. Scambiatterra. Time: 11:15 a.m.

Mr. Thomas escorted me to the Holding Tank Area (*see* photos 3-4). The holding tank area consists of a holding tank that accumulates corrosive plating bath rinse waste (*see* photo 5) and a discharge area for waste discharge to the MWRDGC (*see* photo 6). I noted the area had a sign that read "Satellite Waste Holding Tank." Mr. Thomas informed me that the holding tank (plating rinse waste) was cylinder in shape and he believed it measured three feet deep and three feet in diameter. I noted this tank was full. I asked Mr. Thomas if Circuit had a tank assessment for the holding tank and he replied that to his knowledge, there was not one for the tank.

Description: Holding Tank Area used to collect corrosive plating bath rinses (right side) and the discharge area to the local MWRDGC (left side). This area used to be a WWTS before the facility removed the pre-treatment tanks

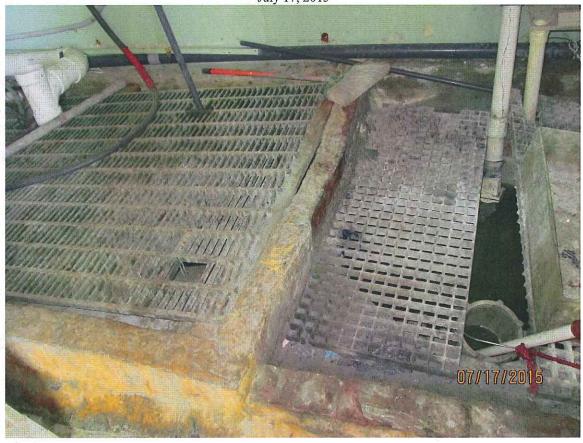
Photo 4. Photographer: G. Scambiatterra. Time: 11:16 a.m.

Description: Holding Tank Area used to collect corrosive plating bath rinses (right side) and the discharge area to the local MWRDGC (left side). This area used to be a WWTS before the facility removed the pre-treatment tanks

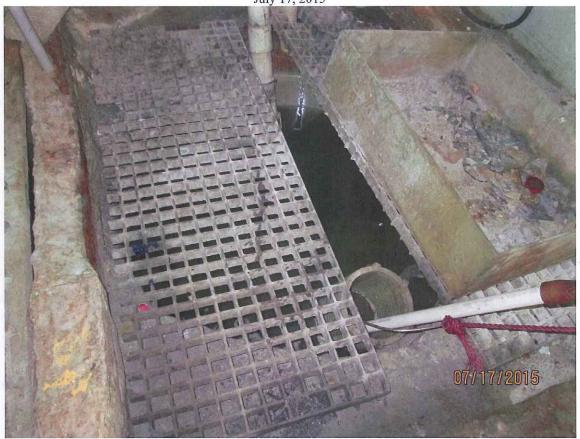
Photo 5. Photographer: G. Scambiatterra. Time: 11:18 a.m. Description: Holding Tank Area used to collect corrosive plating bath rinses. Tank is approximately 3'X3' and was full. Area labeled "Satellite Waste Holding Tank."

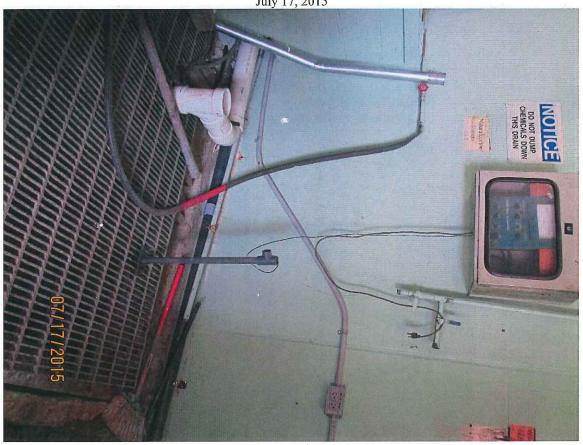
Photo 6. Photographer: G. Scambiatterra. Time: 11:21 a.m. Description: Holding Tank Area - discharge area to the local MWRDGC

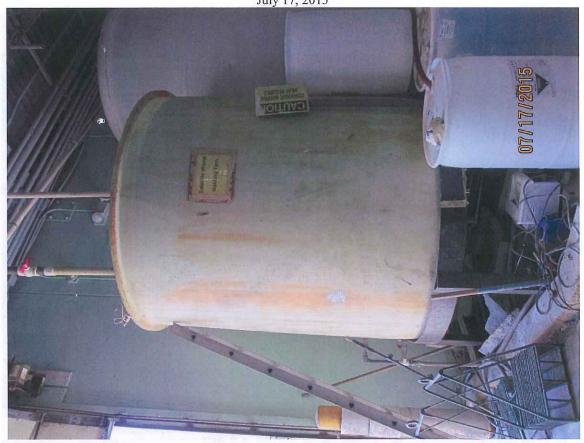
Photo 7. Photographer: G. Scambiatterra. Time: 11:25 a.m.

At the time of the inspection, Circuit did not have a written Certification available for three hazardous waste storage tanks for review to determine if the foundation, structural support, seams, connections, and pressure controls (if applicable) are adequately designed and that the tank system has sufficient structural strength, compatibility with the waste being stored or treated, and corrosion protection so that it will not collapse, rupture, or fail.

The Hazardous Waste Storage Tank Area was near the Holding Tank Area. I observed two tanks. The first was labeled "Satellite Waste Holding Tank" (see photo 7). The second tank was not labeled (see photos 8-9). Both tanks were full. I asked about tank assessments for both tanks and I was informed that Circuit had not obtained one for each tank. Mr. Thomas and Gibson Thorakkal, Circuit employees, informed me that the tank valve had been manually turned off since both tanks were full. Once the tanks reach full capacity, plating rinse waste from the Holding Tank Area will be placed in 55-gallon containers for storage. I noted five 55-gallon containers with the corrosive plating rinse waste (see photos 10-11). None of these containers had any labeling or markings and were not dated with an accumulation start date. Additional empty 55-gallon containers were in the area that are designated to be filled with the corrosive plating waste until such time that the Hazardous Waste Storage Tanks can be emptied and sent offsite for disposal.

Description: Hazardous Waste Storage Tank Area – tank labeled "Satellite Waste Holding Tank" and was at full capacity

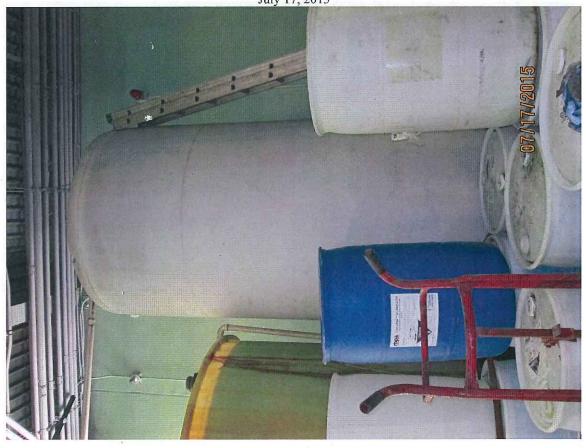
Photo 8. Photographer: G. Scambiatterra. Time: 11:28 a.m.

At the time of the inspection, Circuit was accumulating hazardous waste in five containers and three hazardous waste storage tanks without the words "Hazardous Waste."

Description: Hazardous Waste Storage Tank Area – tank not labeled and was at full capacity

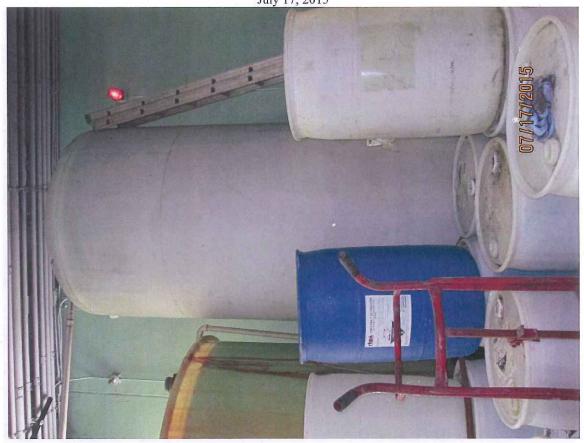
Photo 9. Photographer: G. Scambiatterra. Time: 11:28 a.m.

Description: Hazardous Waste Storage Tank Area – tank not labeled and was at full capacity (blinking red light indicates tanks are at full capacity, according to Mr.

Thorakkal)

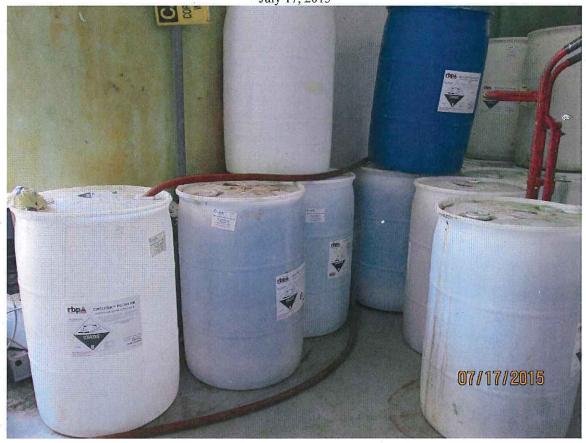
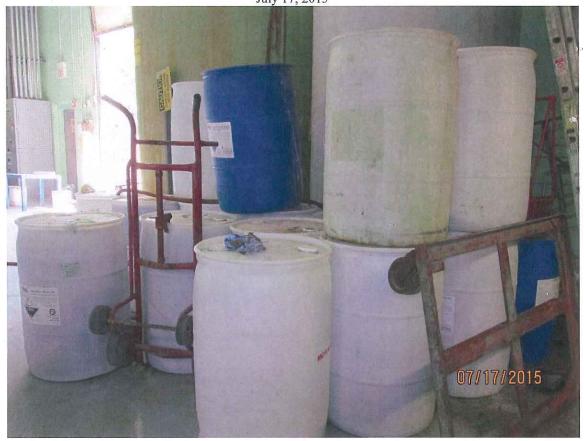
Photo 10. Photographer: G. Scambiatterra. Time: 11:29 a.m.
Description: Hazardous Waste Storage Tank Area. Five 55-gallon containers had corrosive plating rinse waste. They were not labeled and were not dated. All five were full.

At the time of the inspection, Circuit was accumulating five containers of hazardous waste without the accumulation start dates.

At the time of the inspection, Circuit was not inspecting the containers holding hazardous waste in the less than 90-day storage area.

Photo 11. Photographer: G. Scambiatterra. Time: 11:29 a.m.
Description: Hazardous Waste Storage Tank Area. Five 55-gallon containers had corrosive plating rinse waste. They were not labeled and were not dated. All five were full.

At this time, EPA is not requiring Circuit to apply for an Illinois hazardous waste storage permit as long as it immediately establishes compliance with the conditions for a permit exemption outlined in paragraphs 1-5, above.
